Appendix A

Pavement Failure Identification

IDENTIFYING AND CORRECTING PAVEMENT FAILURES

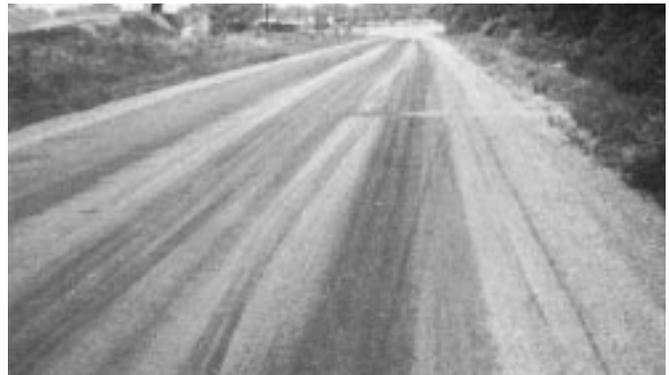
Bleeding or Flushing

This distress is caused by excess asphalt in the surface layer. Contributing factors include insufficient or excess covering stone, lack of proper rolling during placement, or failure to protect a newly constructed surface from traffic until the asphalt has cured sufficiently.

Minor bleeding can often be corrected by applying coarse sand or stone screenings to blot up excess asphalt.

Major bleeding can be corrected by cutting off excess asphalt with a motor grader or removing it with a “heater planer.” If the resulting surface is excessively rough, resurfacing may be necessary.

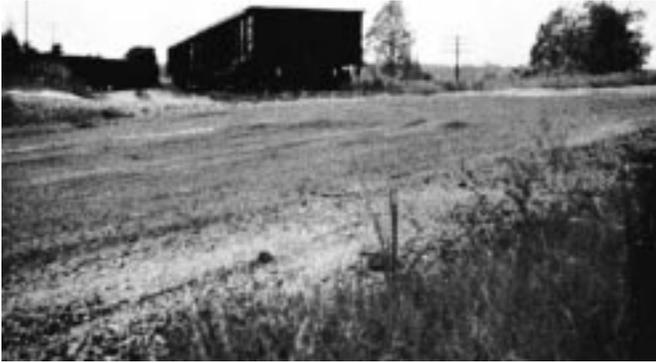
Corrugations and Shoving

Corrugations and shoving are caused by instability in the asphalt layers caused by a mixture that is too rich in asphalt, has too high of a proportion of fine aggregate, has coarse or fine aggregate that is too rounded or too smooth-textured, or has asphalt cement that is too soft. Corrugations and shoving may also be caused by excessive moisture, contamination caused by oil spillage, or lack of curing time between placing seal treatments. This type of distress frequently occurs at grade intersections as a result of braking forces imposed by stopping vehicles.

To repair corrugations in an aggregate base overlain with a thin surface treatment, scarify the pavement, add aggregate as needed, mix well, re-compact, prime, and then resurface. Where the surface has 2 inches or more of asphalt plant mix, corrugations can be removed with a "heater planer." After removal of corrugations, cover with a new surface treatment or new asphalt overlay. To repair shoved areas, remove surface and base as necessary and replace with a more stable material to prevent a recurrence. For out-of-season inclement weather repairs, smooth shoved areas with patching if the surface unevenness is hazardous to traffic.

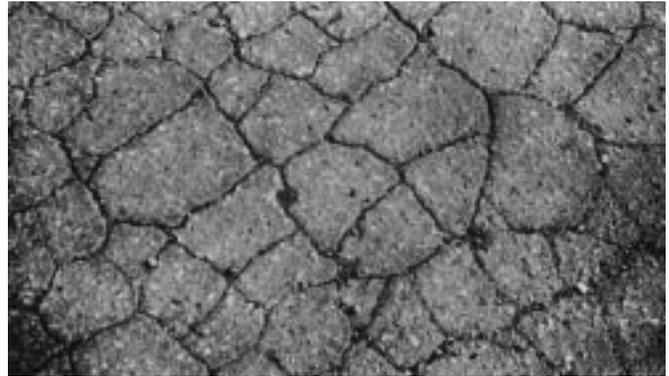
Alligator Cracking without Surface Distortion

Interconnected cracks forming a series of small polygons resembling an alligator's skin are called alligator cracks. There are numerous kinds of alligator cracks, some of which are illustrated and discussed below.

In situ investigations must be performed to determine the most probable of several causes of alligator cracking. If poor drainage is implicated, corrections should be made as quickly as possible. Should the pavement be properly drained, then the base is probably inadequate, and the pavement will require reconstruction or a heavy resurfacing. Major resurfacing will also be required if cracking results from the fatigue effect of repetitive heavy truck loads. If the cause of distress

Skin patching should be applied when weather permits. This is often a temporary measure and should not be considered a permanent correction of a major problem. Alligator cracking generally requires removal of the cracked pavement and an asphalt patch of at least 4 inches in depth.

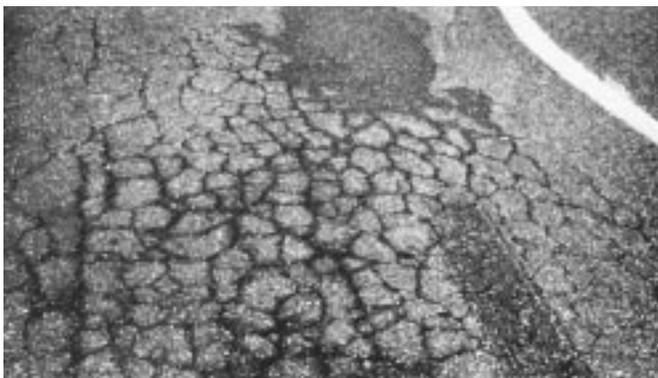
Alligator Cracking with Surface Distortion and Pumping

There are several causes of this type of distress. Often poor drainage resulting in a wet base and/or subgrade is responsible. If the pavement is properly drained, then water is getting to the base and/or subgrade from cracks or holes in the surface or from moisture coming up through the subgrade.

This distress should be repaired as follows:

1. Cut out pavement and wet material.
2. If the base or surface is wet from underneath, install necessary underdrains to prevent future saturation.
3. Prime area.
4. Replace with a minimum of 4 inches of Asphalt Concrete.
5. Compact Asphalt Concrete.

For out-of-season inclement weather repair, keep the area filled with either cold patch material or treated aggregate base.

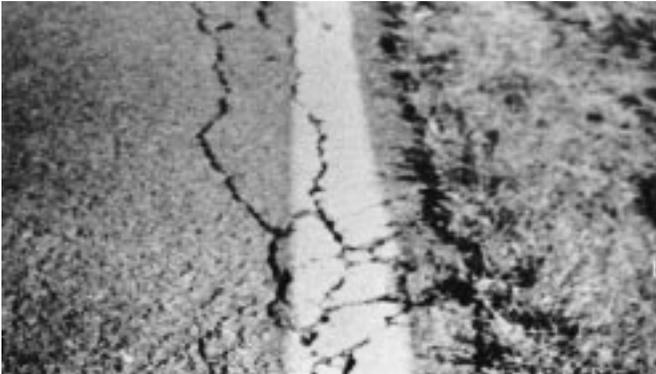
Edge Cracks without Surface Distortion

Cracking without surface distortion is usually caused by lack of shoulder (lateral) support. When the surface is distorted, possible causes are more diverse. In some cases, the base layer may be of insufficient quality or thickness to support the traffic loads. Poor drainage is also a frequent cause. Is water getting in from the top, sides, or bottom? Is base failure causing distortion and allowing water to wet the base and/or subgrade? Is a clogged ditch line causing water to seep through porous shoulder material and saturate the base and subgrade? Corrective measures should be undertaken as soon as possible.

The first step is to correct the problem of lack of lateral support if necessary. For cracks less than 1/4 inch in width, no maintenance is required. A skin patch is sufficient for larger cracks.

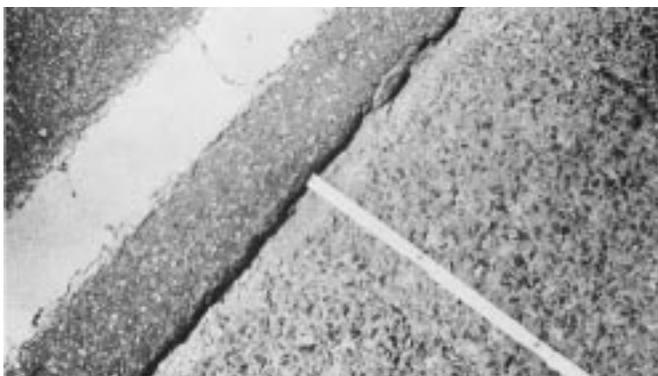
Joint Crack at Pavement Edge

This distress is caused by wetting or drying action beneath the shoulder surface caused by conditions that trap water and allow it to stand along and seep through the joint between the shoulder and the mainline surface.

If the cracking is less than 1/4 inch in width, no maintenance is required. Otherwise, a crack should be filled with a cutback or emulsified asphalt.

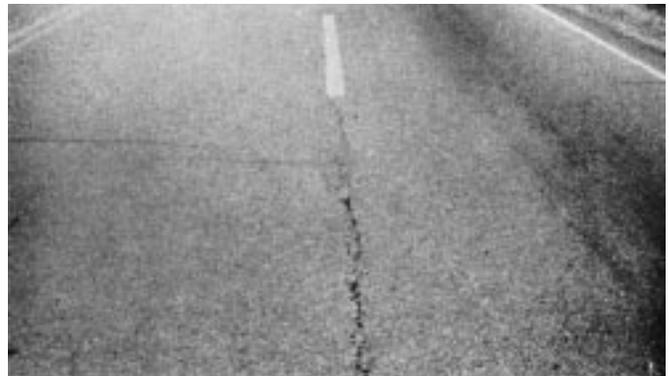
Joint Crack at Lane Joints

Distress is caused by a weak seam between adjoining spreads in the courses of the pavement.

If the cracking is less than 1/4 inch in width, no maintenance is required. Otherwise, the crack should be filled with a cutback or emulsified asphalt.

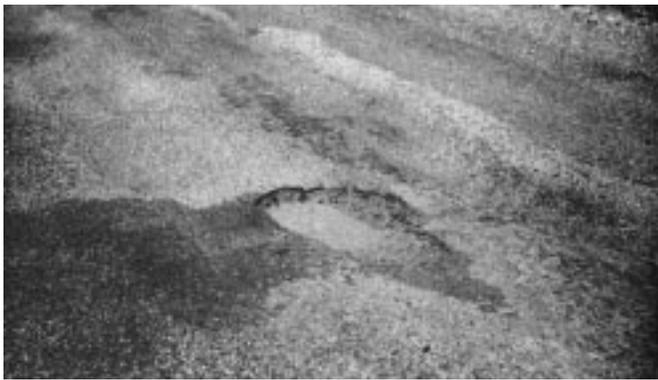
Potholes in Surface Treatments over Aggregate Base

Potholes are caused by water penetrating the surface and causing the base and/or subgrade to become wet and unstable. They also may be caused by a surface that is too thin or that lacks

sufficient asphalt content, lacks sufficient base, or has too many or too few fines. Did you and/or your personnel fail to perform maintenance that would have prevented pothole formation? If water is the culprit, it is caused by a cracked surface, high shoulders or pavement depressions ponding water on the pavement, porous or open surface, or clogged side ditches? Correct the cause of the problem as soon as possible.

To repair potholes in surface treatments, take the following actions:

1. Clean out hole.
2. Remove any wet base.
3. Shape hole so that it has vertical sides.
4. Prime hole.
5. Fill hole with Asphalt Concrete.

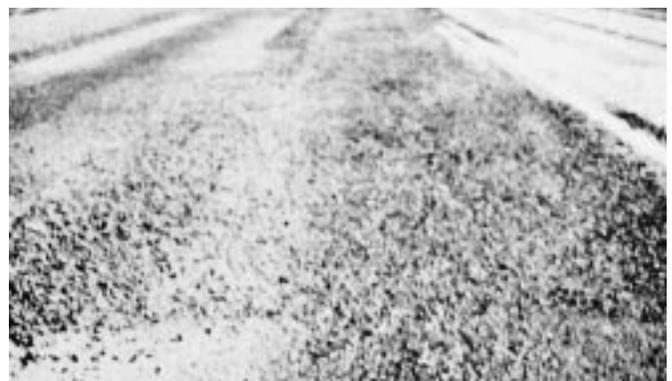
Raveling is caused by a dry brittle surface; dirty, dusty, or soft aggregate; patching beyond base material; lack of compaction of surface during construction; too little asphalt in mix; or excessive heating during mixing.

When a small percentage of the pavement is raveling, repair with a skin patch (this includes edge raveling). When a large percentage of the pavement shows raveling, the pavement should be resurfaced.

Note: If the raveling is not a part of the paved surface, no action should be taken. In other words, don't patch beyond the edge of the pavement.

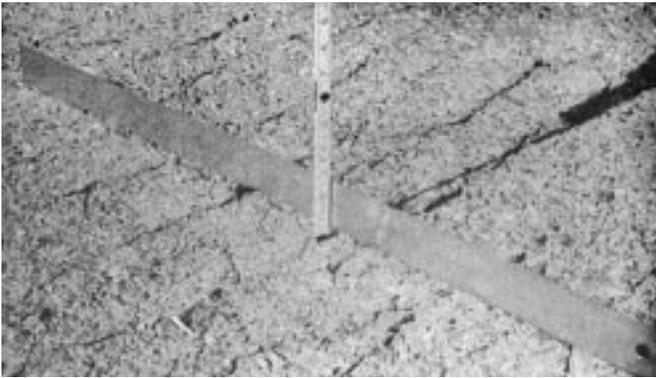
Intact Surface

Channels are caused by heavy loads and high tire pressures, subgrade settlement caused by saturation, poor construction methods, or asphalt mixtures of inadequate strength.

Where the depression is 1 inch or less and the surface is cracked but still largely intact, skin patch the area. Where the depression is more than 1 inch and the surface is cracked but still largely intact, repair with asphalt concrete.
